Village of Medina

2010 Street Tree Risk Survey Report

**Prepared for:
Village of Medina, New York
Department of Public Works**

February, 2010

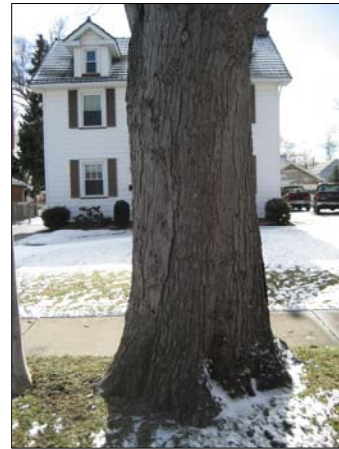
Defective trees were evaluated for removal. If pruning more than 33% of the trees live crown was required to remove the defective parts and the tree was in poor condition, the tree was recommended for removal. Some removals may appear healthy, however in many cases there is severe trunk decay (as pictured to the right) that is not readily evident and the tree is a high failure risk.

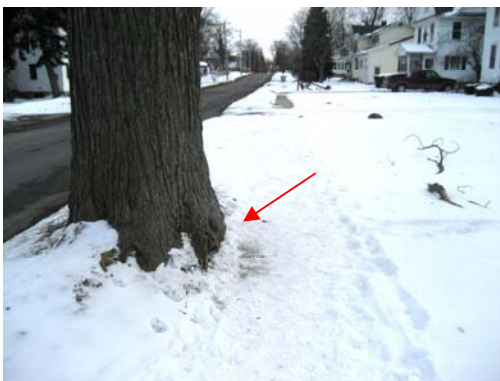
The roots were cut to install the sidewalk. Decay has entered the tree and now it is a failure risk and needs to be removed.

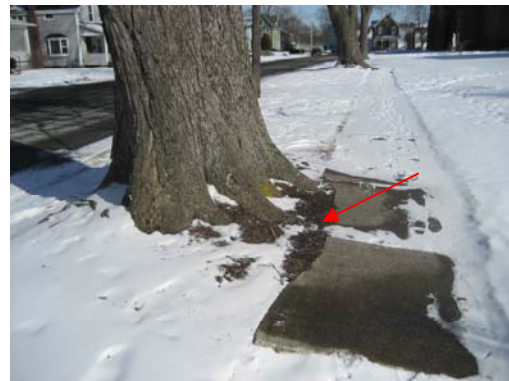
The sidewalk was curved around the tree roots protecting the tree.
